MONTHLY UPDATE REPORT - PRIMROSE SOUTH 09-21-067-04 W4M

MAY 19 TO JUNE 22, 2015

The Canadian Natural Resources Limited Primrose South in situ oil sands project is located in the Cold Lake Air Weapons Range (CLAWR) approximately 65 km north-northeast of Bonnyville, Alberta. Canadian Natural operations staff discovered a bitumen emulsion flow to surface (FTS) area at 09-21-067-04 W4M on June 24, 2013. The bitumen emulsion FTS area is beneath an unnamed water body located within the Canadian Natural Primrose South production area.

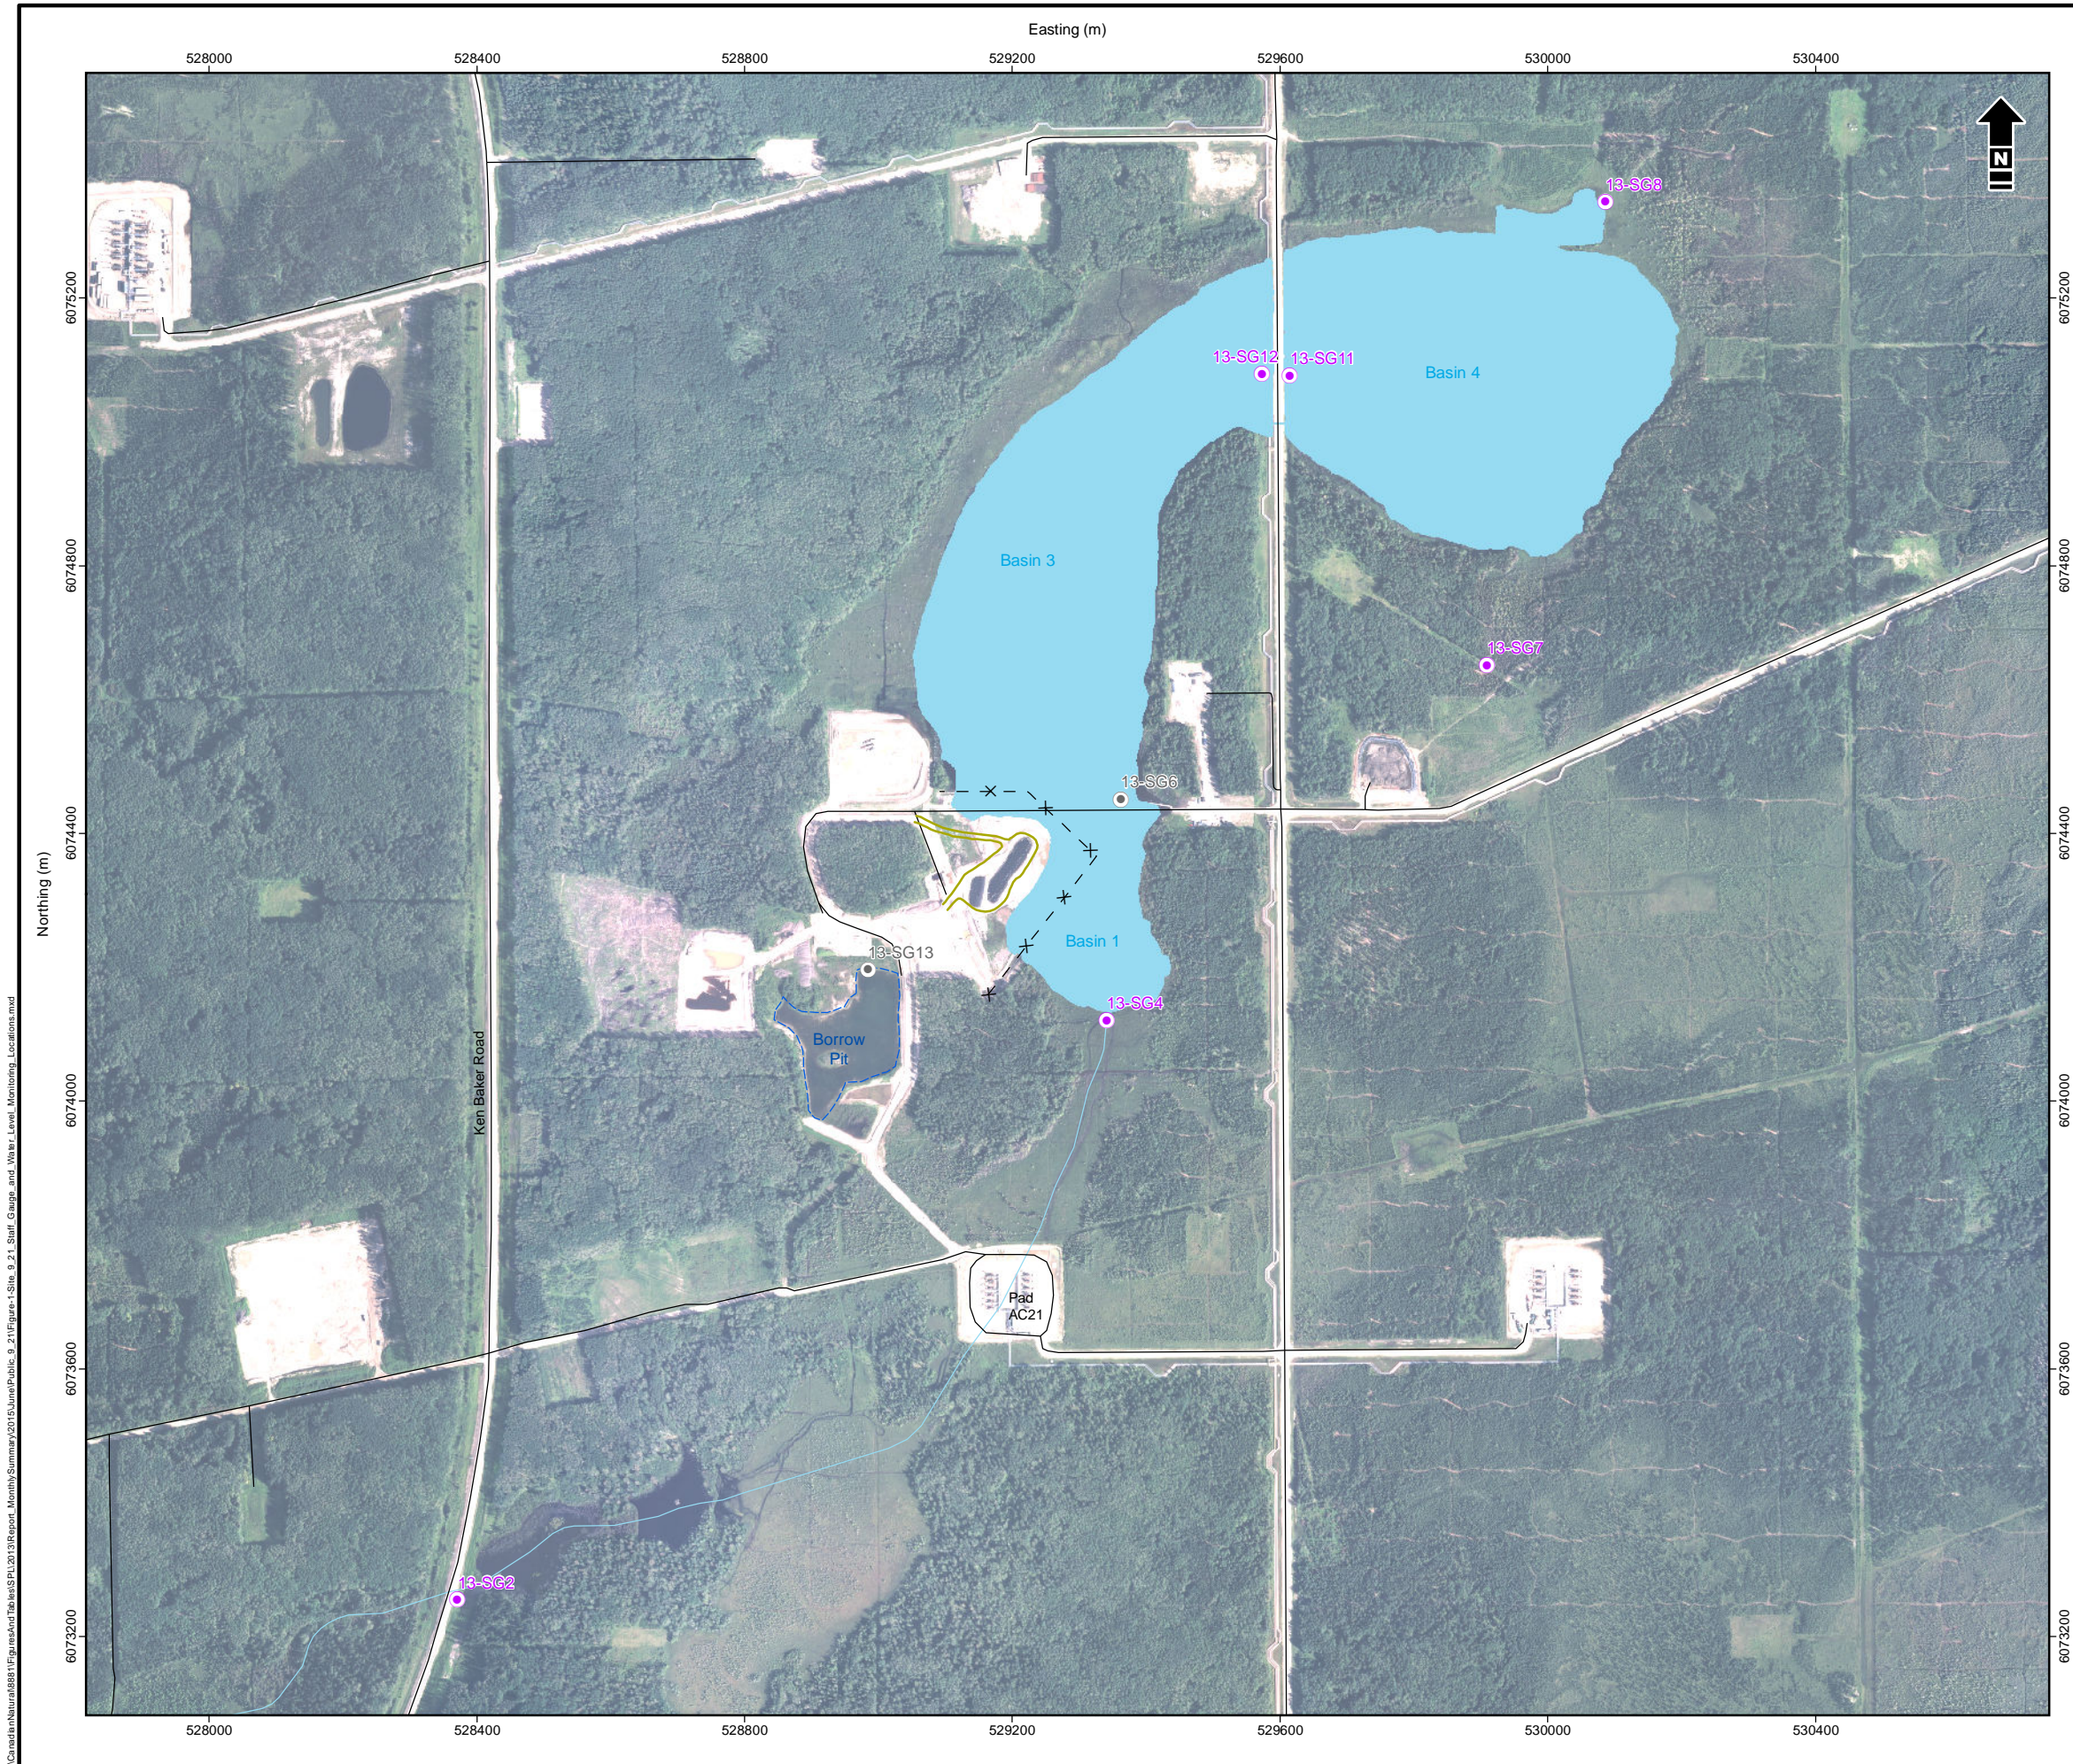
Site 9-21 Staff Gauge and Water Level Monitoring Locations

Staff gauge and water level monitoring locations are shown on Figure 1. The staff gauges have not been resurveyed since breakup and the water body elevations are approximate; these staff gauges will be resurveyed in July 2015. Staff gauges (13-SG11 and 13-SG12) were monitored on June 19, 2015.

The results of the staff gauge readings and corresponding water levels for Basins 3 and 4 are shown on Appendix A. The water level within Basins 3 and 4 is approximately 699.63 +/-0.1 m above sea level.

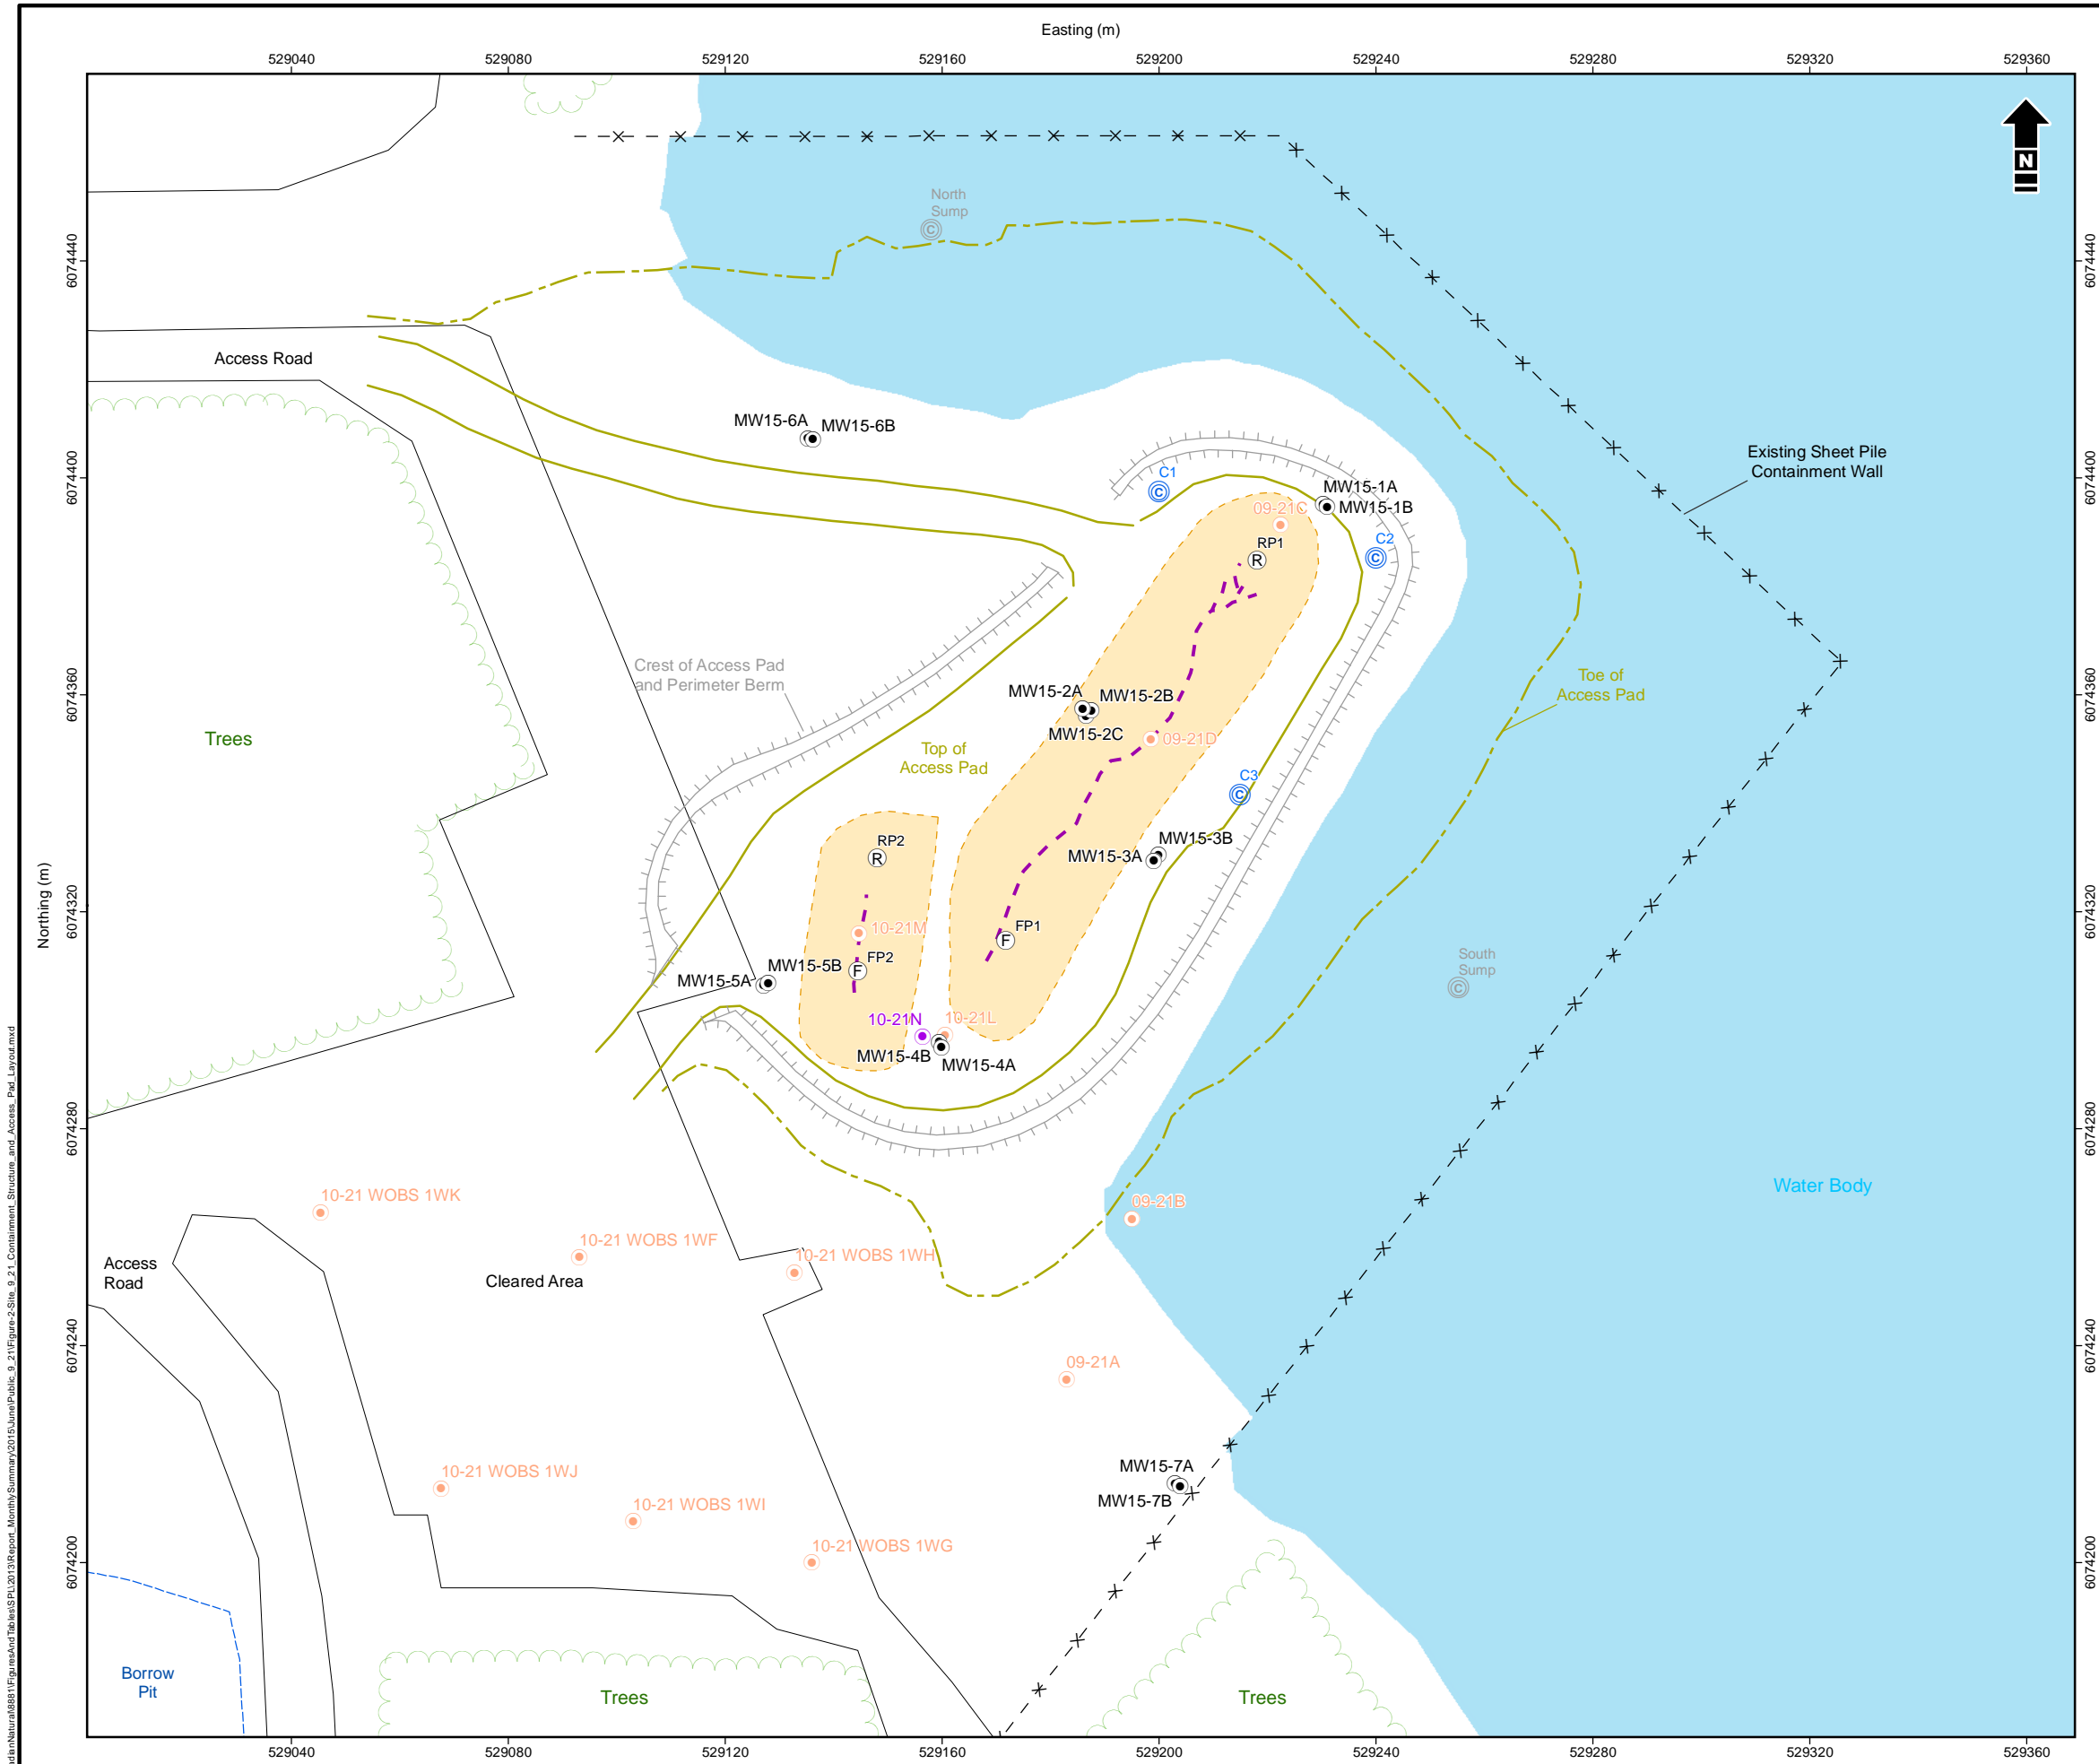
Figure 2

The containment structure area is now flooded and considered to be part of the water body although the containment wall remains in place. Water quality samples were collected from within the water collection trench located beneath the access pad (East Sump C2). The trench water was tested in the laboratory and all parameters were within the applicable guidelines. This finding confirmed that the quality of water seeping into the trench from the water body meet the necessary quality requirements to allow the water to be pumped directly back into the water body (Figure 2). Water quality results are provided in Appendix B.
