MONTHLY UPDATE REPORT - PRIMROSE SOUTH 09-21-067-04 W4M

JULY 21 TO AUGUST 24, 2015

Site 9-21 Staff Gauge and Water Level Monitoring Locations

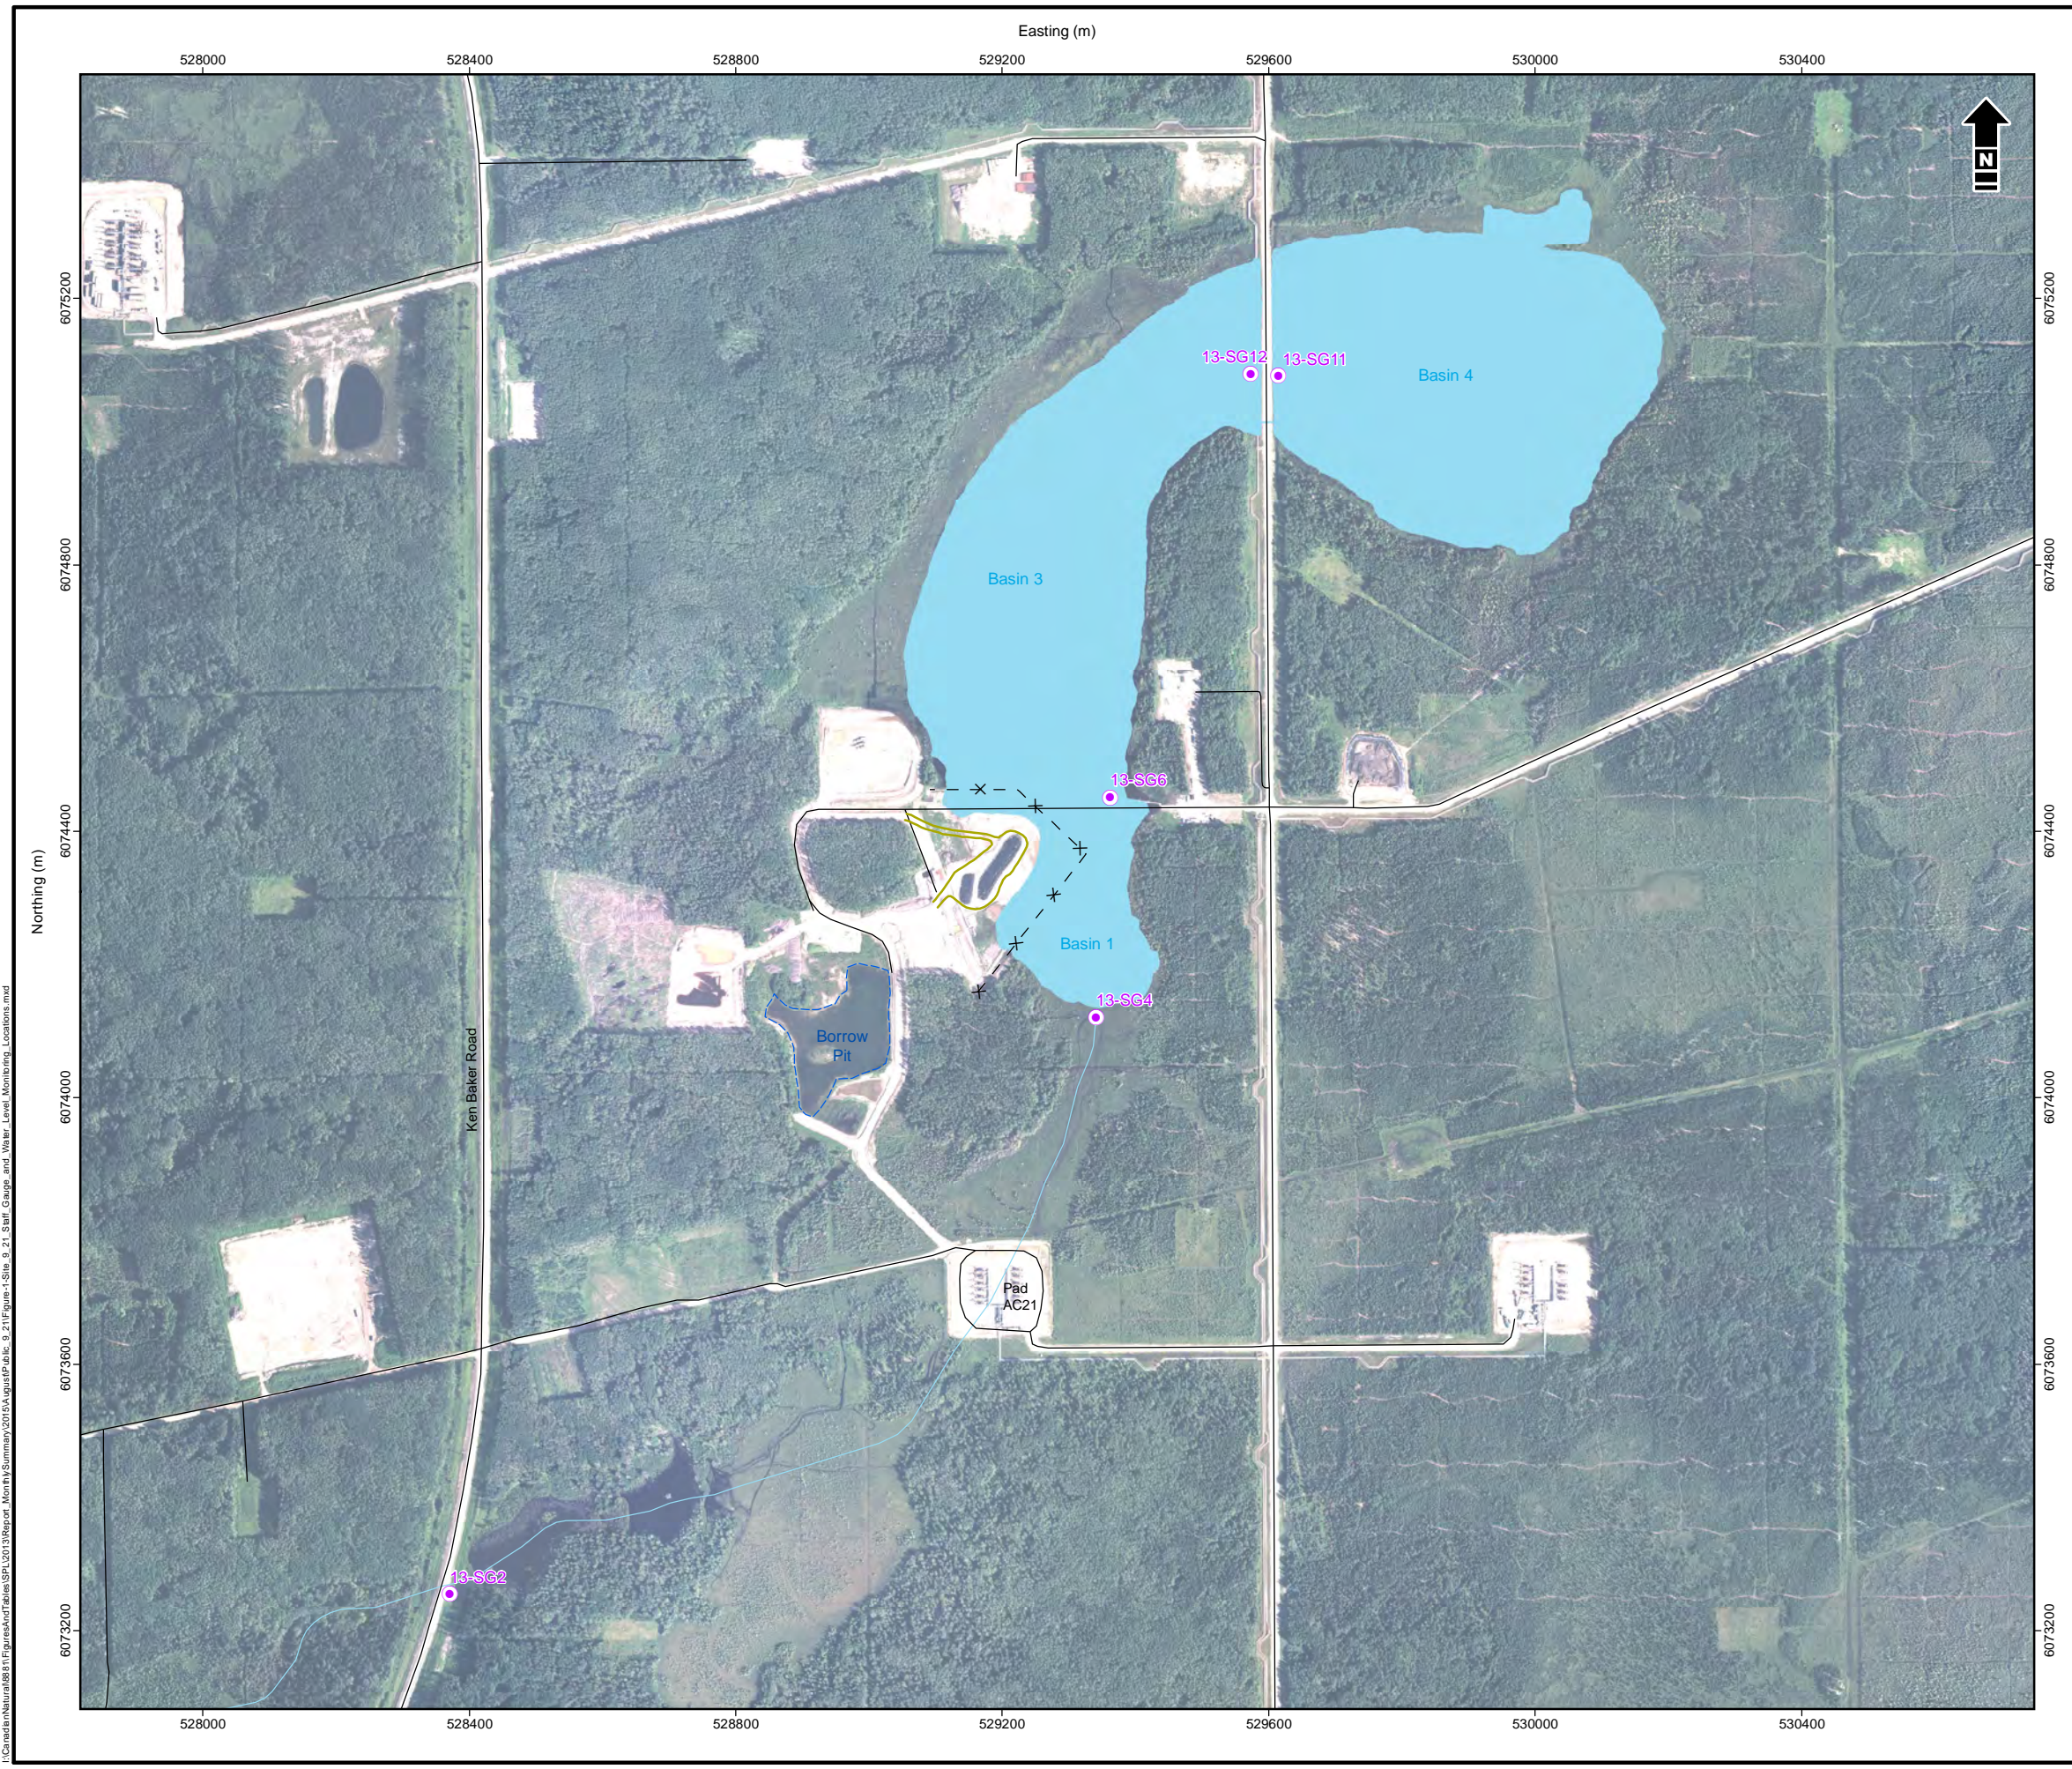
Water level staff gauges and monitoring locations are shown on Figure 1. The staff gauges have not been resurveyed since breakup and the water body elevations are approximate; these staff gauges will be resurveyed in September 2015. Staff gauges (13-SG2, 13-SG4, 13-SG11, and 13-SG12) were monitored on August 20, 2015. Staff gauge 13-SG6 was not monitored as a reading of the staff gauge from the shore was not possible. The results of the staff gauge readings and corresponding water elevations for Basins 3 and 4 are shown on Appendix A1. The results of the staff gauge readings and corresponding water elevations for the fen are shown on Appendix A2. The water level elevations within Basins 3 and 4 were approximately 699.6 m above sea level (m asl), which is within range of historical measurements before dewatering and refilling (~699.5 m asl).

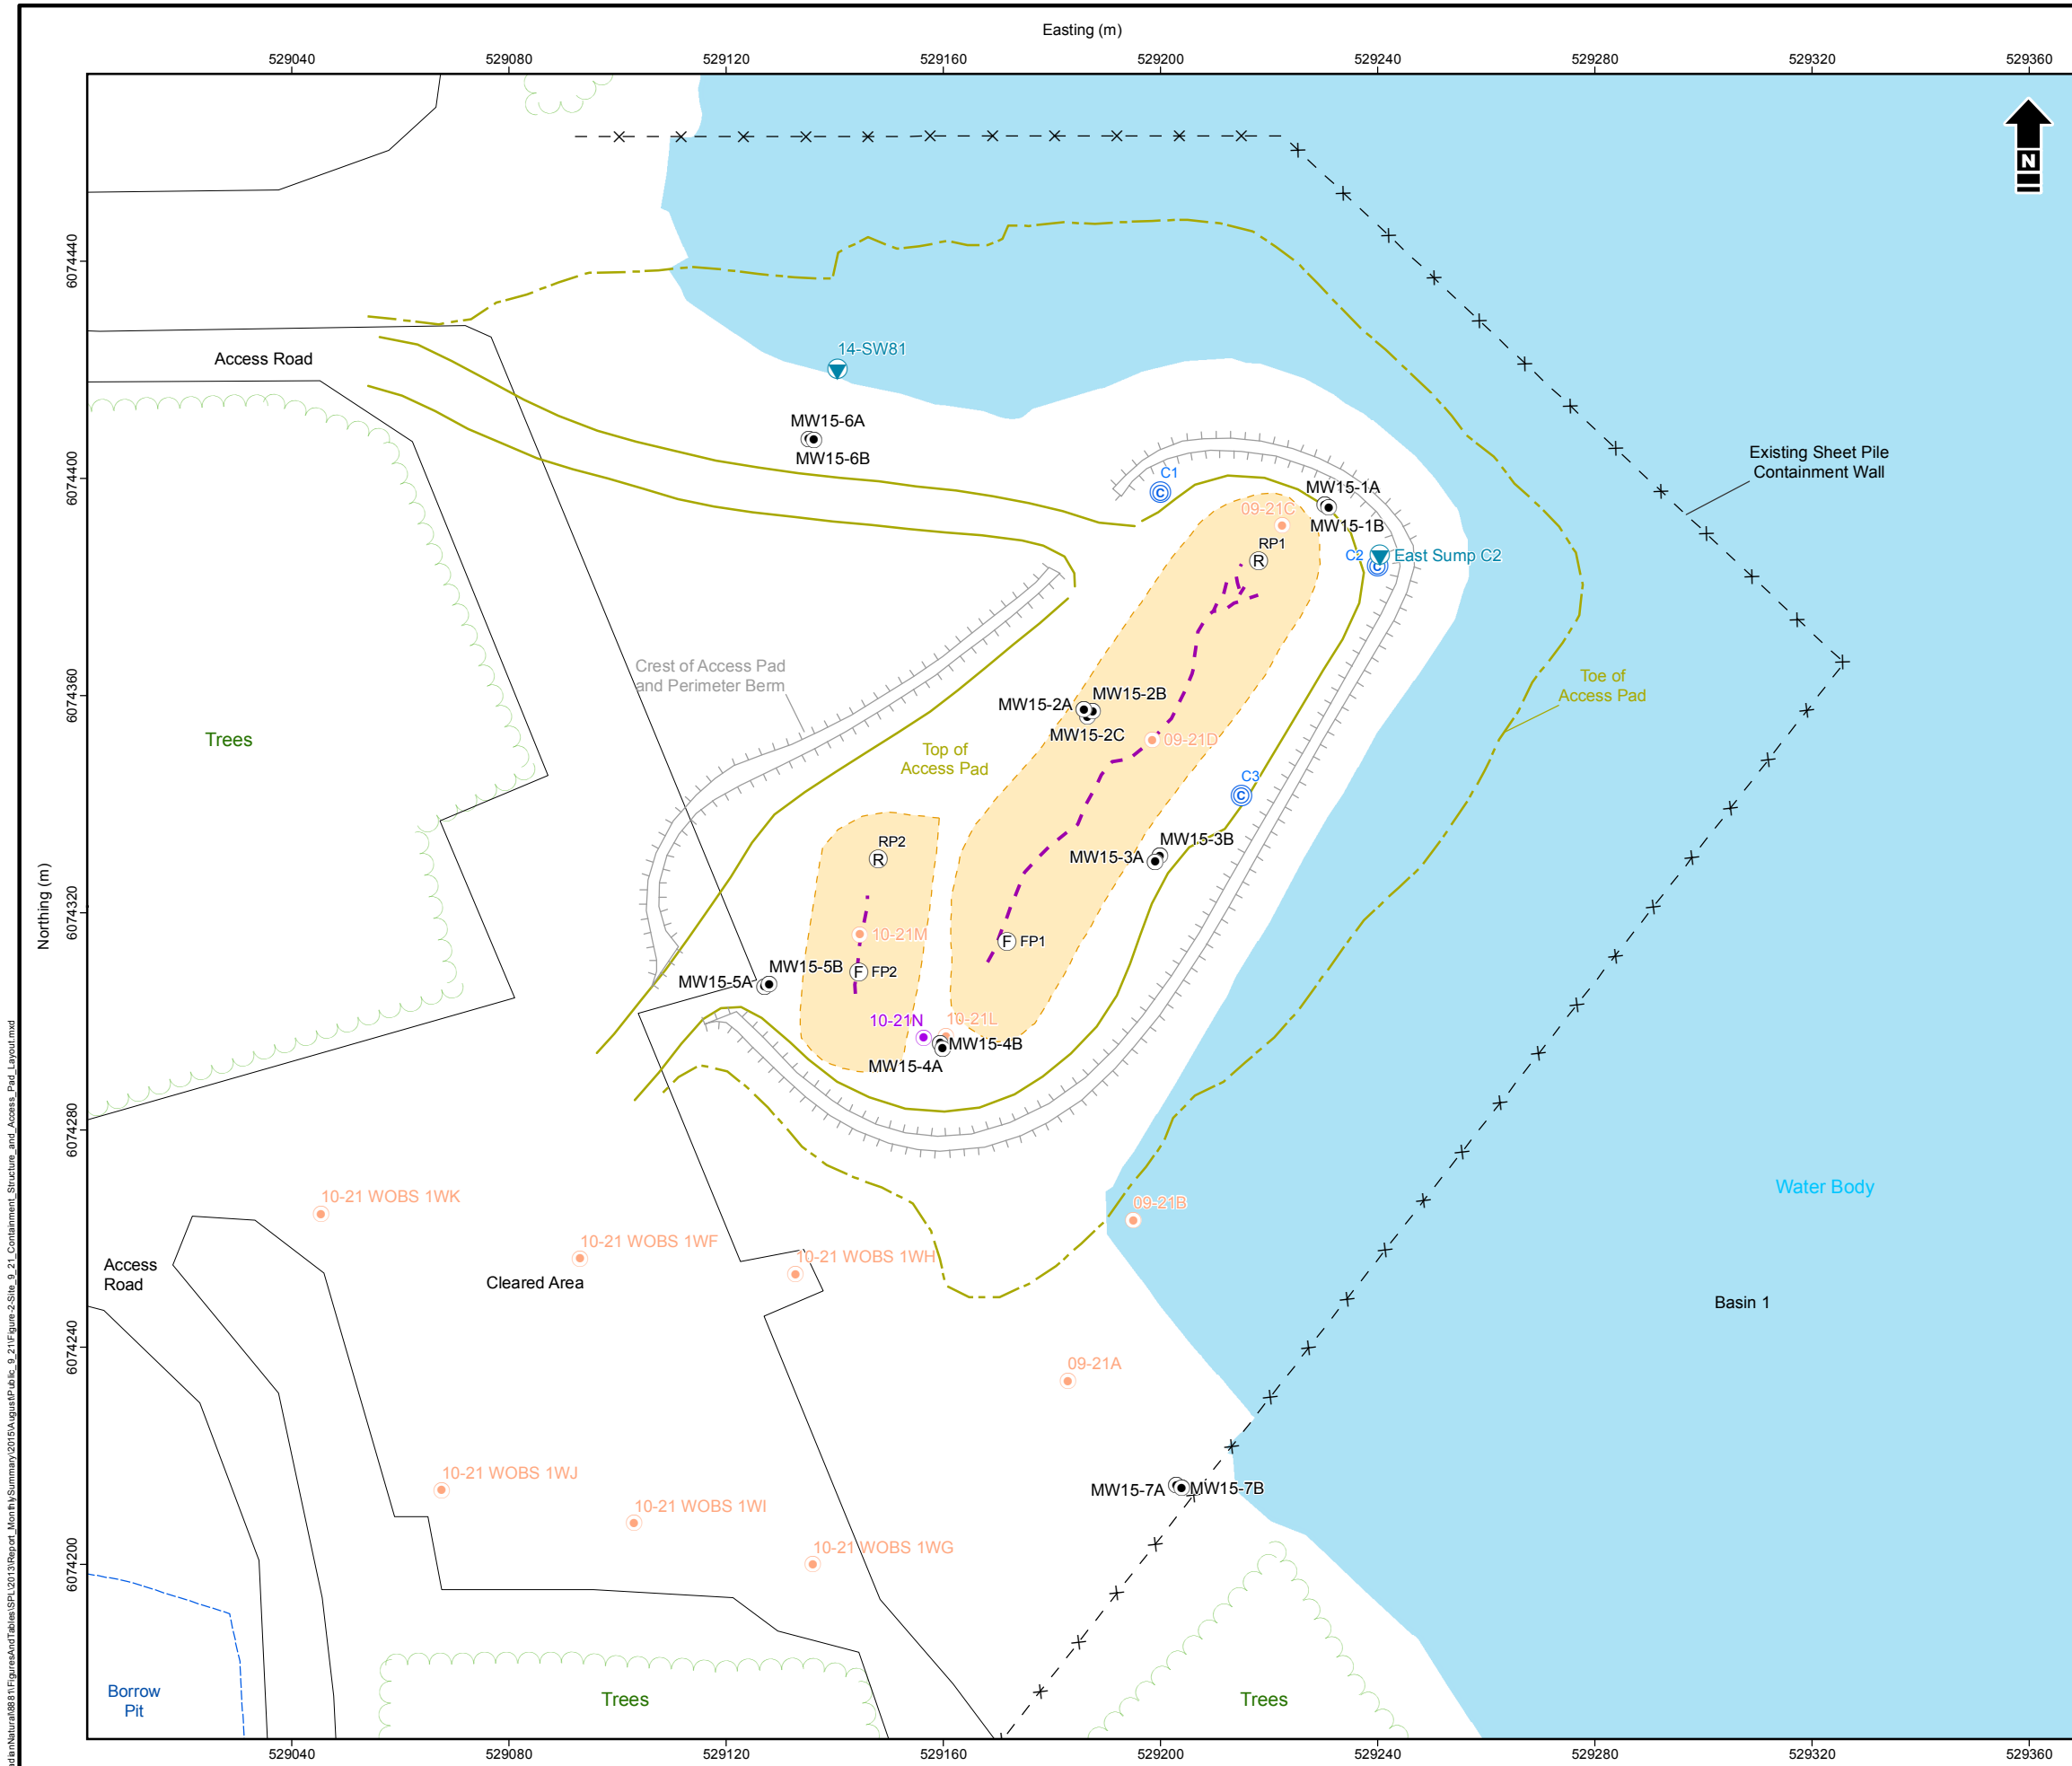
Site 9-21 Containment Structure and Access Pad Layout

The containment structure area is now flooded and considered to be part of the water body although the containment wall remains in place. Water quality samples were collected from within the flooded containment structure (14-SW81) and from within the water collection trench located beneath the access pad (East Sump C2) on August 4, 2015 (Figure 2).

Laboratory analysis of water samples was carried out for benzene, toluene, ethylbenzene, and xylenes (BTEX); petroleum hydrocarbons (PHC) fraction 1 (C₆-C₁₀, excluding BTEX), and fraction 2 (C_{>10}-C₁₆); and polycyclic aromatic hydrocarbons (PAH). PHC and PAH water quality results are provided in Appendix B. All water quality results were within applicable guidelines.
